St. Louis Country Club Golf Course Drainage

Project Information

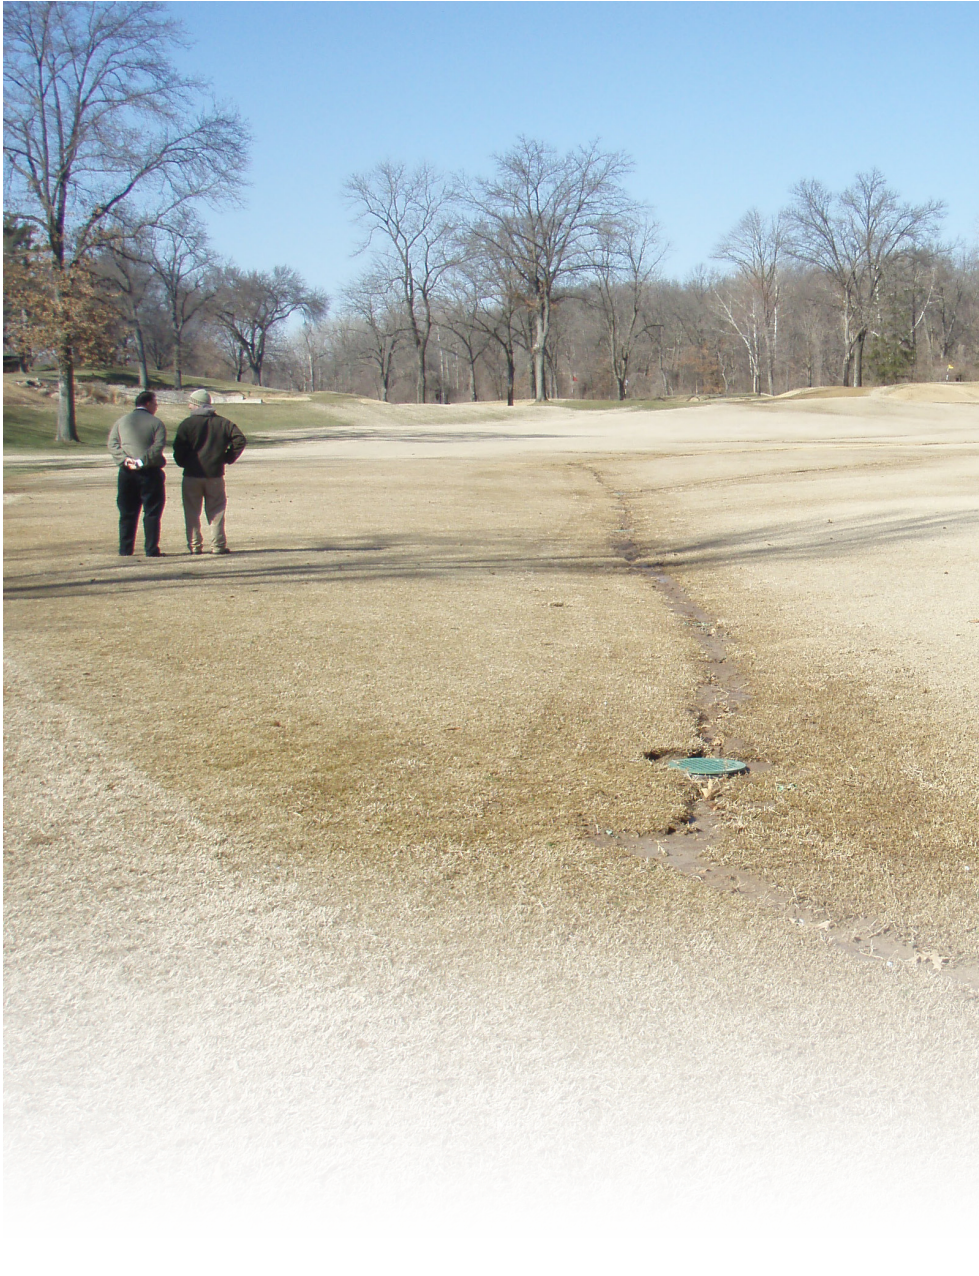
The golf course superintendent surveys the final installation in early Spring 2012.

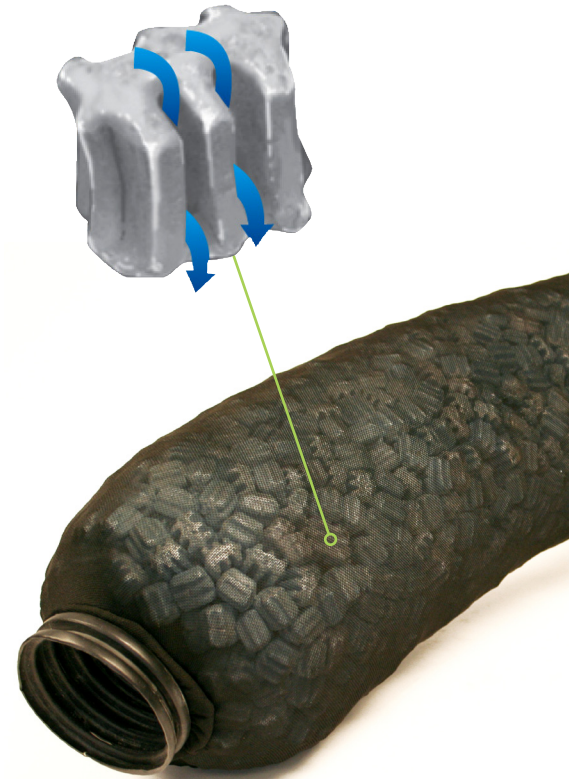
EZflow poly-rock aggregate is engineered with “flow channels” to increase void space.

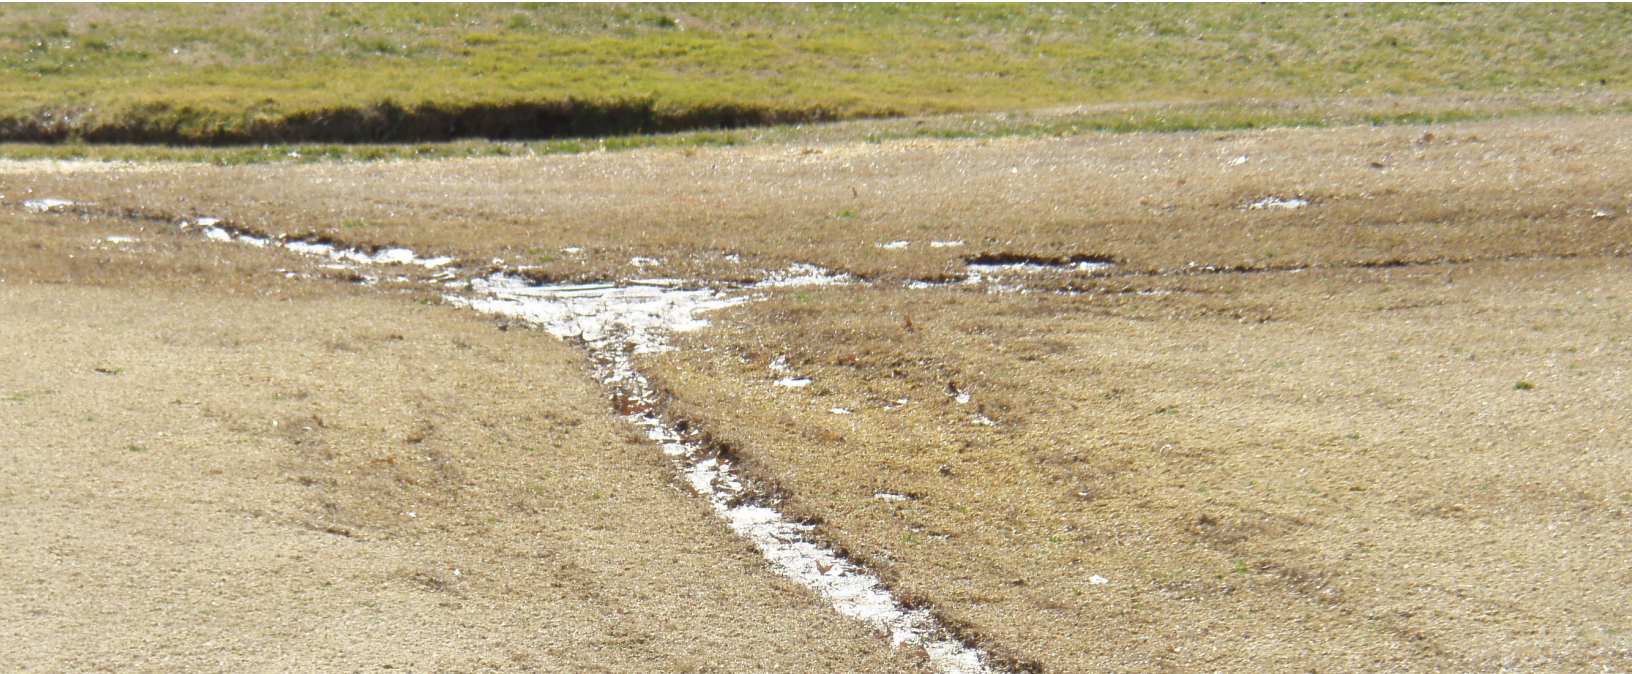
Installation of EZflow along the fairway in early spring.
